3.4 DAINGERFIELD ISLAND SITE

3.4.2 Conceptual Site Plan

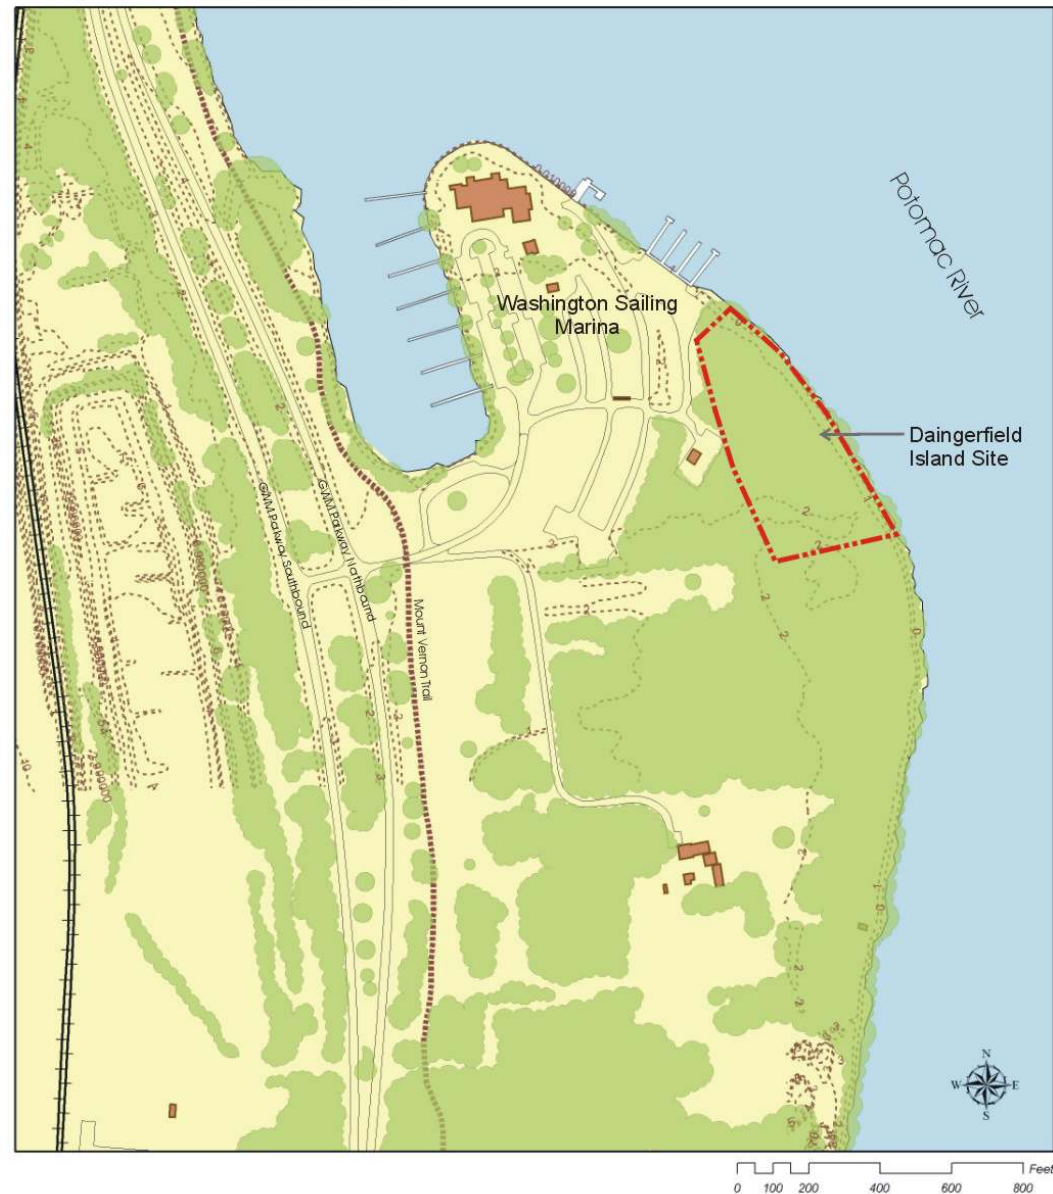
Figure 3.53: Existing Conditions, Daingerfield Island Site

The site is located at the eastern end of Daingerfield Island, to the south of the existing Washington Sailing Marina. See Figure 3.53. The site is a recreational/open space area under the ownership of the NPS.

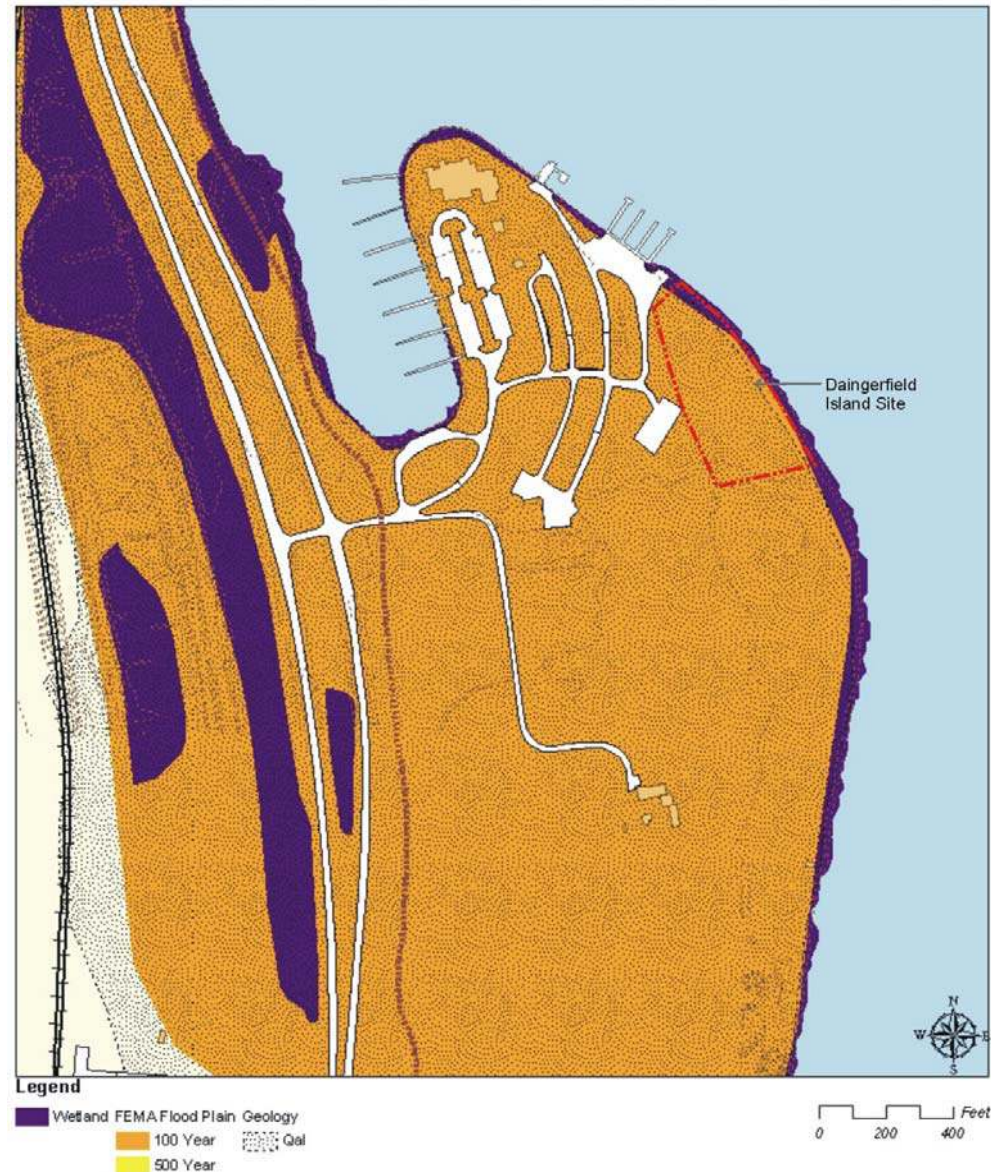
Figure 3.54: Existing Soils and Hydrology, Daingerfield Island Site

- **Floodplains:** According to FEMA mapping, the entire Daingerfield Island site is within the 100-year floodplain of the Potomac River (FEMA. 1982).
- **Wetlands:** National Wetland Inventory data indicates that there are wetlands at the Potomac shoreline along the extent of the Daingerfield Island site (see Figure 3.54).

- **Soils:** Soils at the Daingerfield Island site are likely Udorthents, as described for the lower Rosslyn site (Hydel 2001). The soils on the Daingerfield Island site are well vegetated. The riverbank exhibits some signs of erosion such as bank loss and root exposure. However, the bank appears to have previously been stabilized with riprap (see Figure 3.54).

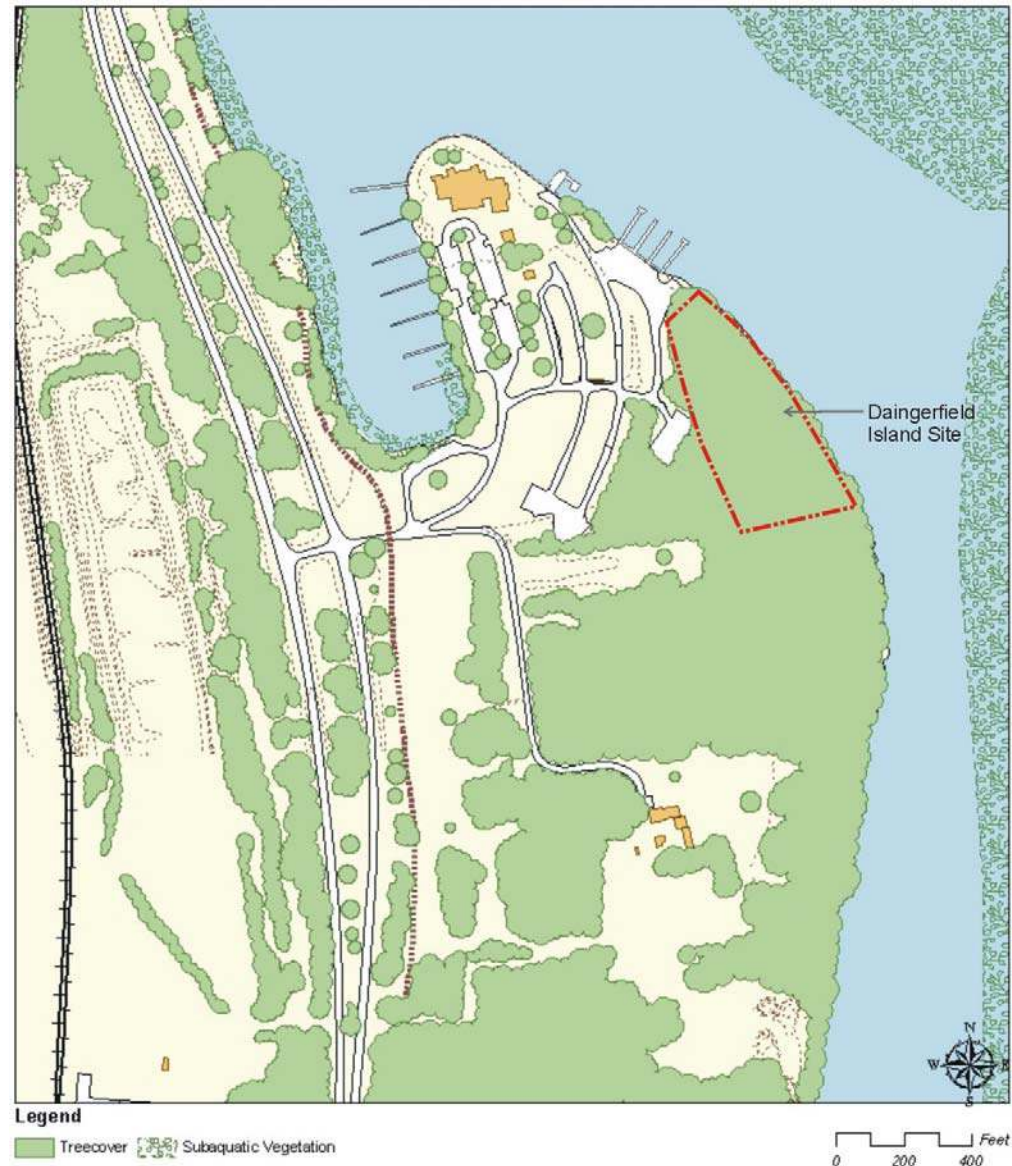
Figure 3.55: Existing Vegetation, Daingerfield Island Site

suitable for supporting rarities than do the more altered Upper Rosslyn and 14th Street Bridge sites for the boathouse, and recommends an inventory of suitable habitat on the Daingerfield Island site (see Figure 3.55).

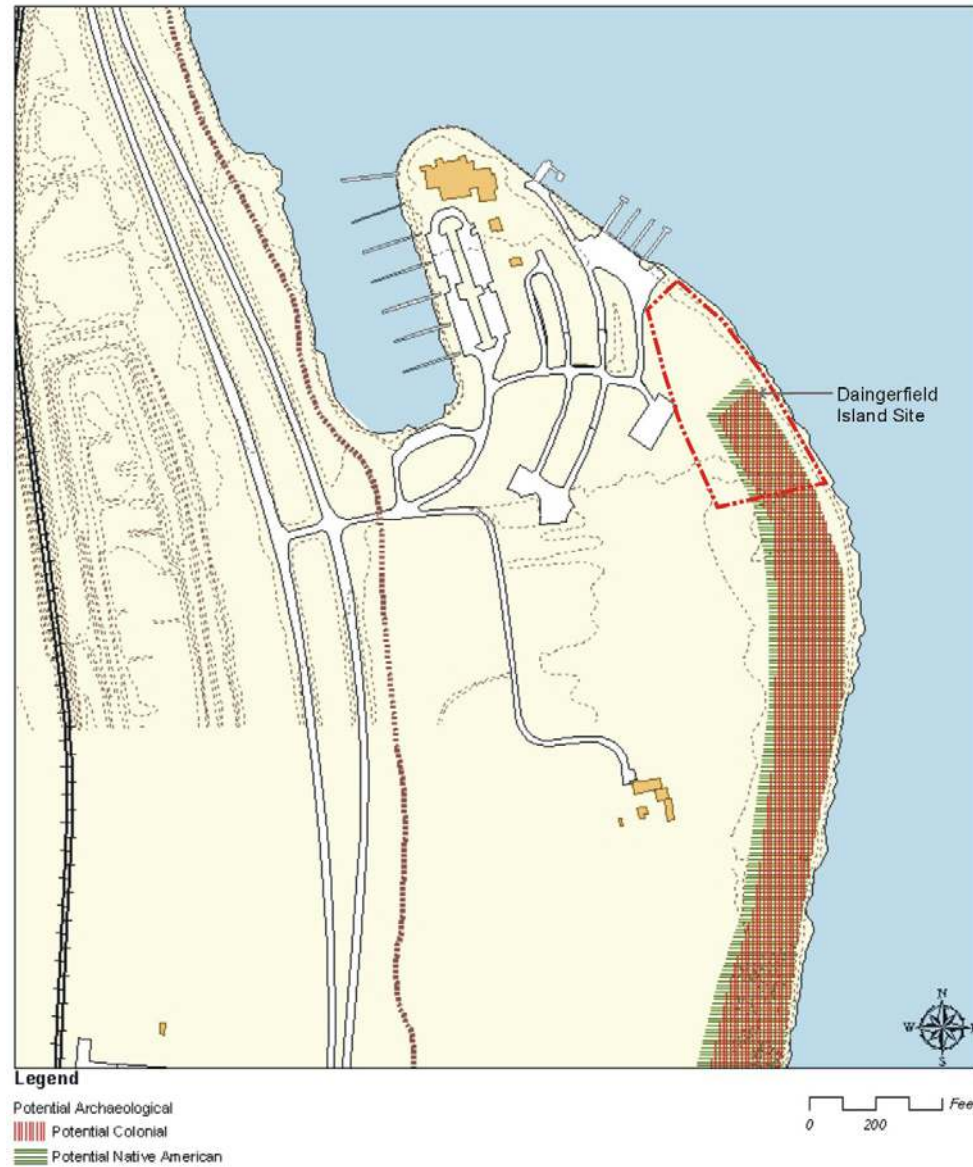
Figure 3.57: Potential Existing Historical/Cultural Resources, Daingerfield Island Site

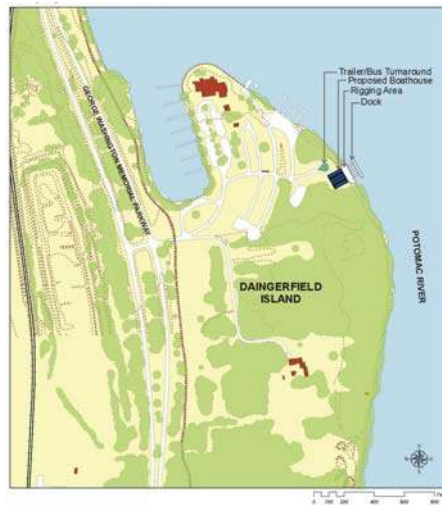
Figure 3.58: Conceptual Site Plan

Two conceptual plans were prepared to test the potential of locating a boathouse at this site. Figures 3.58 and 3.59 illustrate a smaller boathouse with a footprint of 10,000 SF. Figure 3.60 illustrates a larger boathouse with a footprint of 14,000 SF. In both plans, a new access road with a drop-off area, off the existing road network, is proposed. The boathouse and docks are proposed slightly

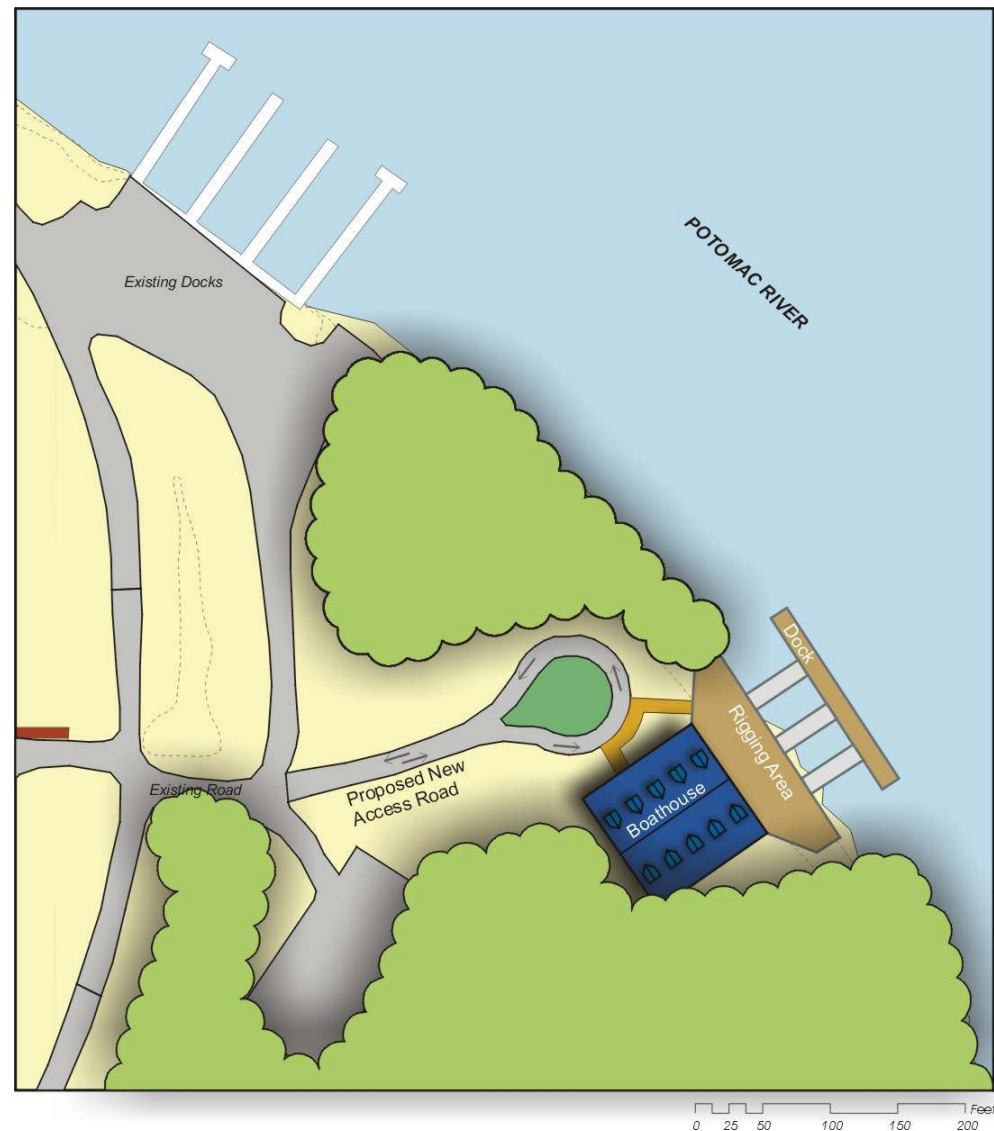
Figure 3.59: Enlarged Conceptual Site Plan, Minimum Program Boathouse

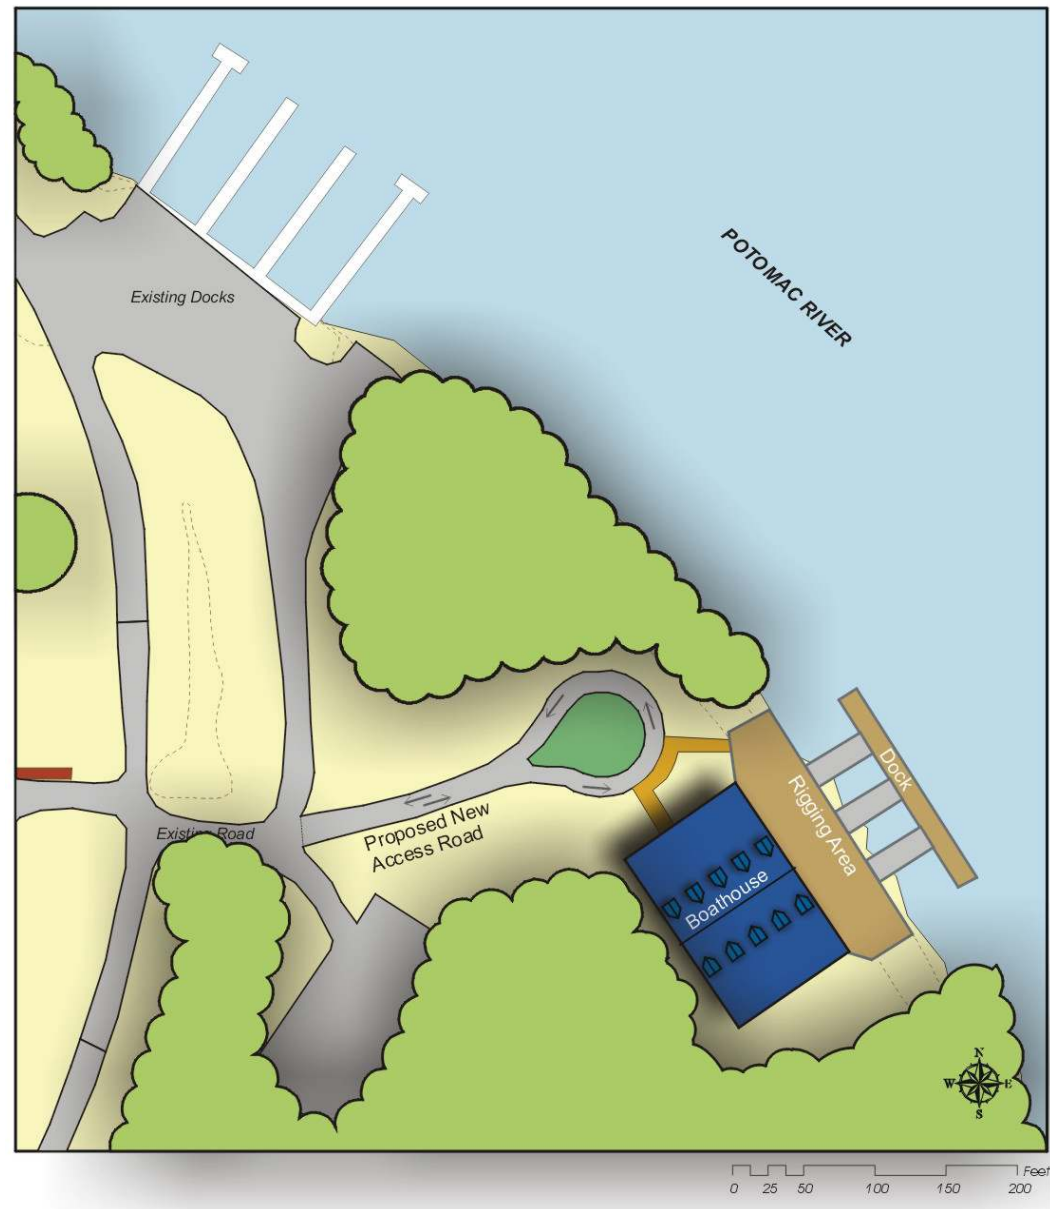
Figure 3.60: Conceptual Site Plan, Maximum Program Boathouse

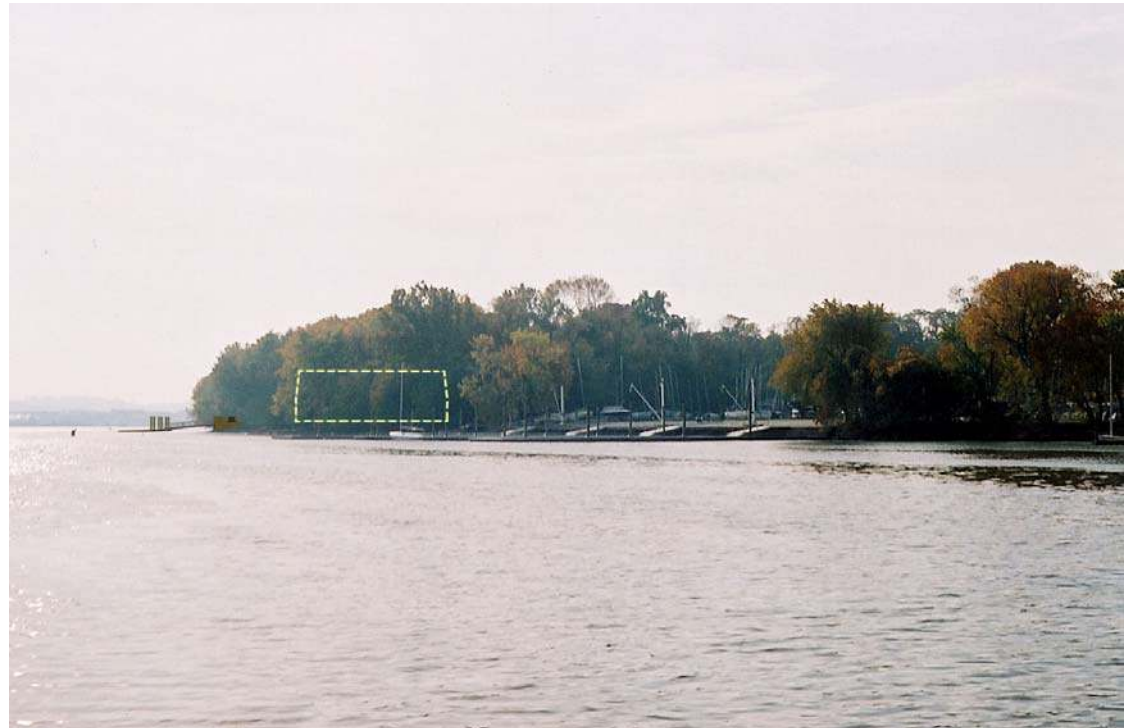
Figure 3.63: Simulation of Proposed Smaller Boathouse – View from Upstream along the Potomac River

View 1: From the Potomac River, north of the Daingerfield Island, the boathouse would not be visible (see Figure 3.63). However, the docks would be visible. The boathouse would be located just beyond an existing stand of trees (shown here by an outline).

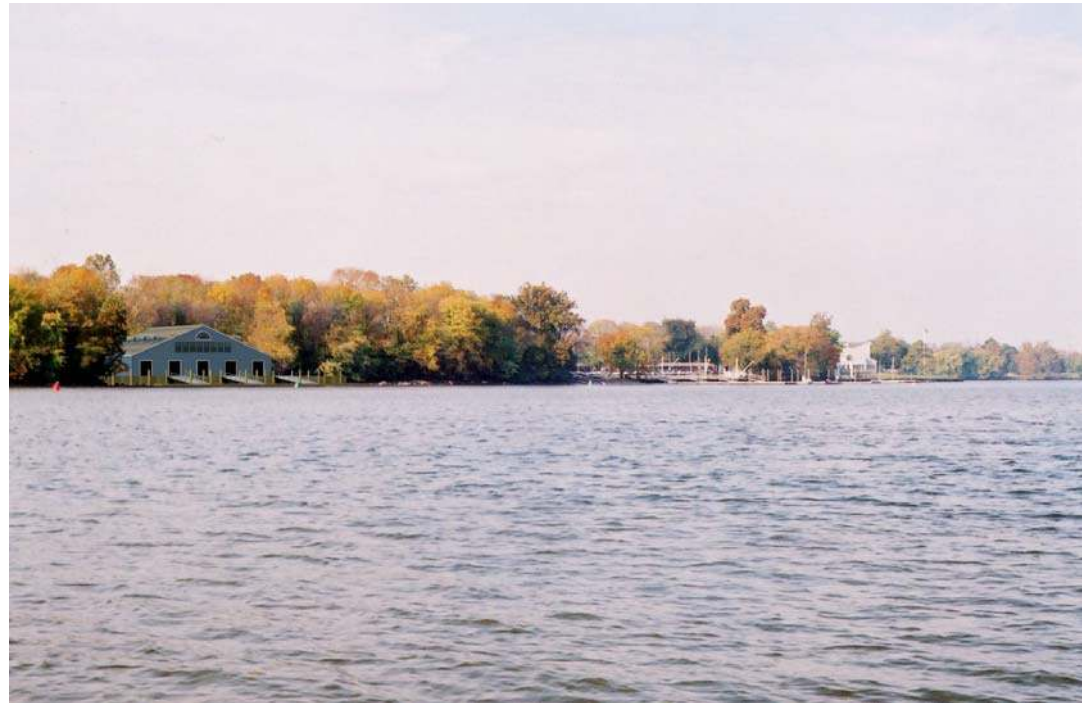
Figure 3.65: Simulation of Proposed Smaller Boathouse – View from Downstream along the Potomac River

View 2: From the Potomac River, south of the Daingerfield Island, the boathouse and the docks would be visible within the strand of existing trees (see Figure 3.65). The simulation illustrates the relationship of the proposed boathouse to the existing piers for Washington Sailing Marina.

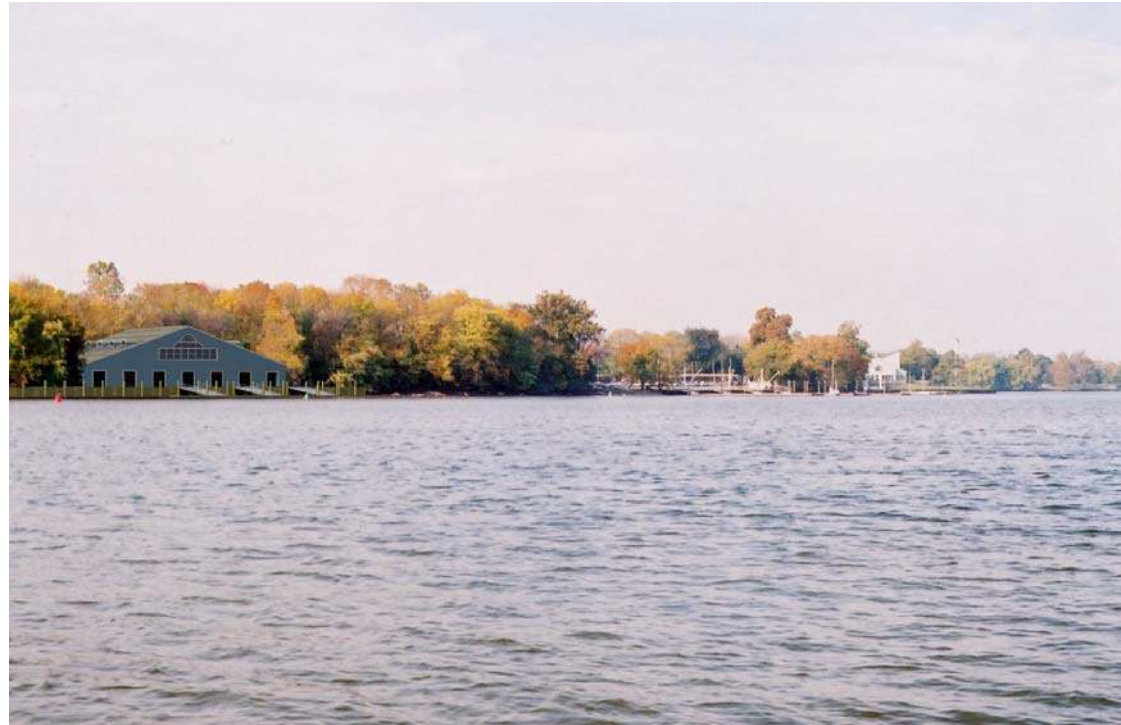
Figure 3.67: Simulation of Proposed Larger Boathouse – View from Downstream along the Potomac River

View 3: From the Potomac River, south of the Daingerfield Island, the larger boathouse and the docks would be visible within the strand of existing trees (see Figure 3.67). The larger boathouse would have a greater potential impact due to its larger size.
